WEST LEECHBURG RESERVOIR DAM

**PHASE I INSPECTION REPORT
NATIONAL DAM INSPECTION PROGRAM**

GAI CONSULTANTS, INC.
570 BEATTY ROAD
MONROEVILLE, PENNSYLVANIA 15146
OCTOBER 1978

PHASE I INSPECTION REPORT
NATIONAL DAM INSPECTION PROGRAM
WEST LEECHBURG RESERVOIR DAM
NDI# PA-452, PENNDA# 65-108

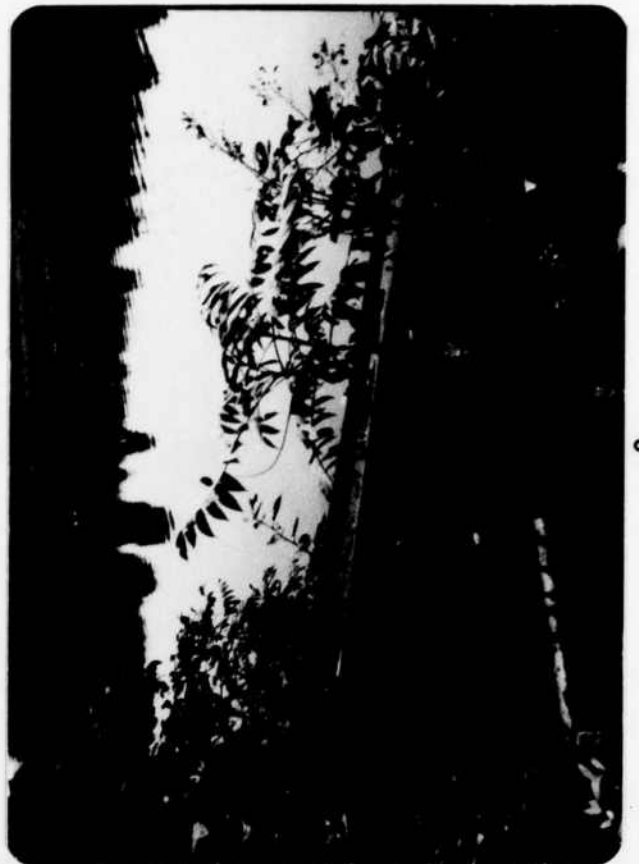
the authority to decant water from five (5) elevations within the reservoir. Reportedly, the gates are corroded open and cannot be closed. Because of this condition, there is no way to regulate flow on the inlet end of the outlet works.

The low level intake located at the base of the upstream embankment toe was submerged during the inspection and could not be observed. Four additional intakes are located along a conduit which ascends the reservoir slope along the left shoreline approximately 175 feet upstream of the embankment and can be observed as it juts out from below pool level. All intakes are reportedly open and inoperable. The visible portion of the conduit is corroded.

PHOTOGRAPH 8 Closeup view of the intake system located upstream of the spillway. The valve stem on the outside of the pipe is connected to a gate on the blow-off line.

c. Modify or repair the outlet system so as to provide a method for controlling discharge at the inlet end of the 24-inch diameter outlet pipe.

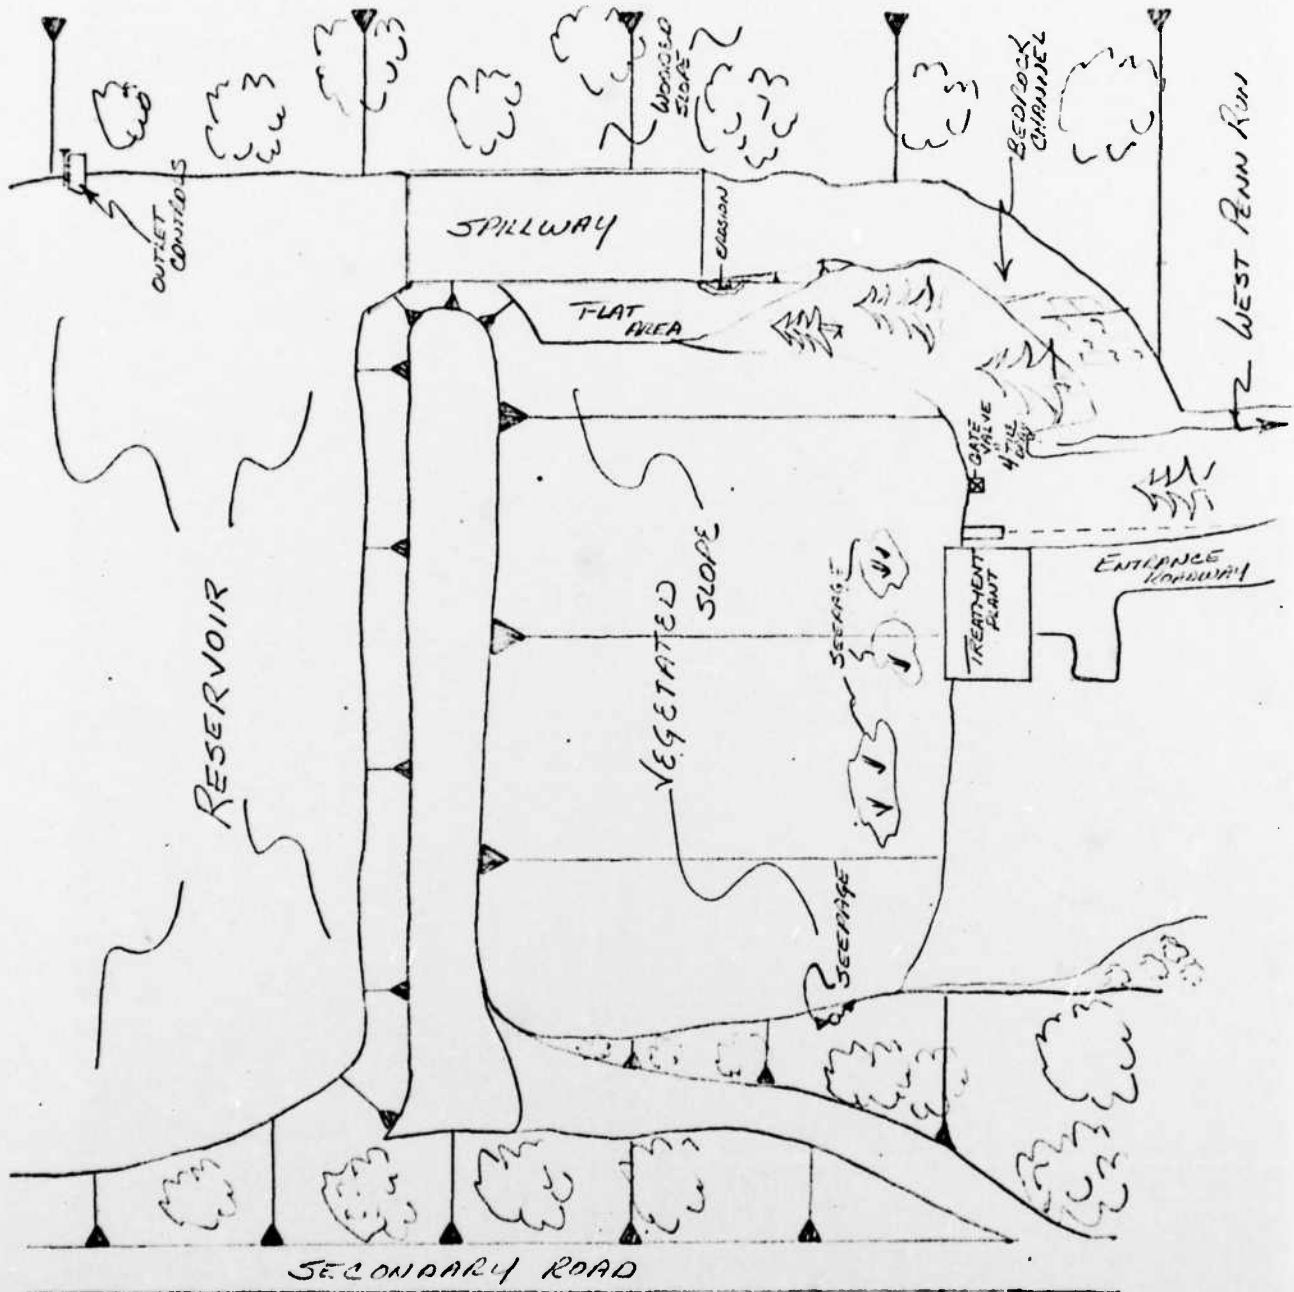
FIGURE 1

Seepage noted above the toe of the dam behind the treatment plant. Flow could not be measured; however, a large area (see sketch in Appendix F) was saturated. Seepage was also observed emanating from the right abutment hillside downstream of the dam and from a tile drain in the stream channel to the left of the treatment plant.

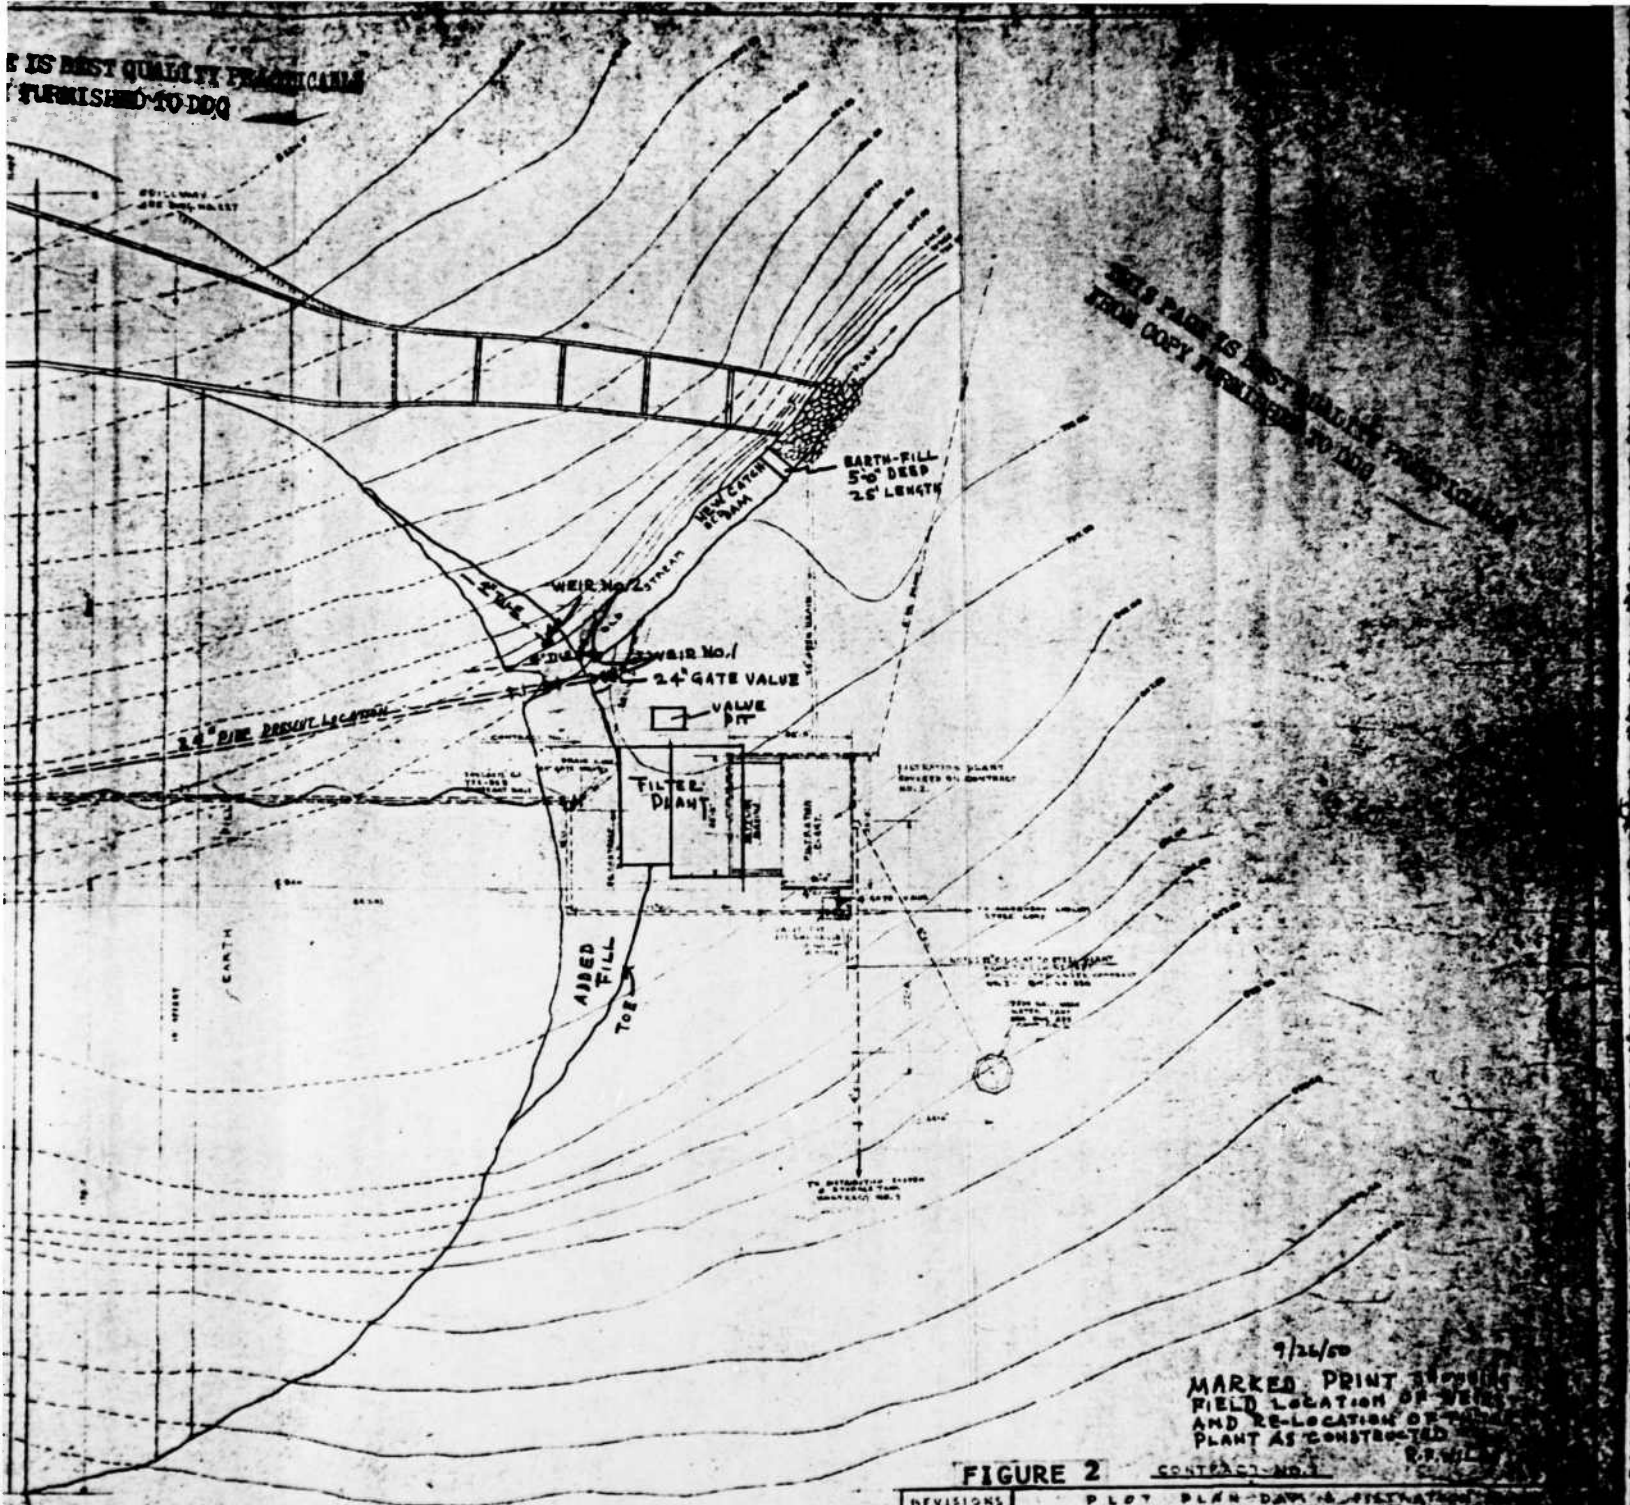
FIGURE 2 CONTRACT NO. 1

Tile drains observed adjacent to the discharge of the blow-off conduit located approximately 25 feet to the left of the treatment facility at the toe of the embankment. The location of the drain lines are shown on design drawings (see Figure 2, Appendix F).
